TUNNEL INSPECTION REPORT

ST. ELIZABETHS HOSPITAL – WEST CAMPUS
WASHINGTON, D.C.

Report Prepared by:
Burgess & Niple, Inc.
4160 Pleasant Valley Road
Chantilly, VA 20151

Date: February 2006

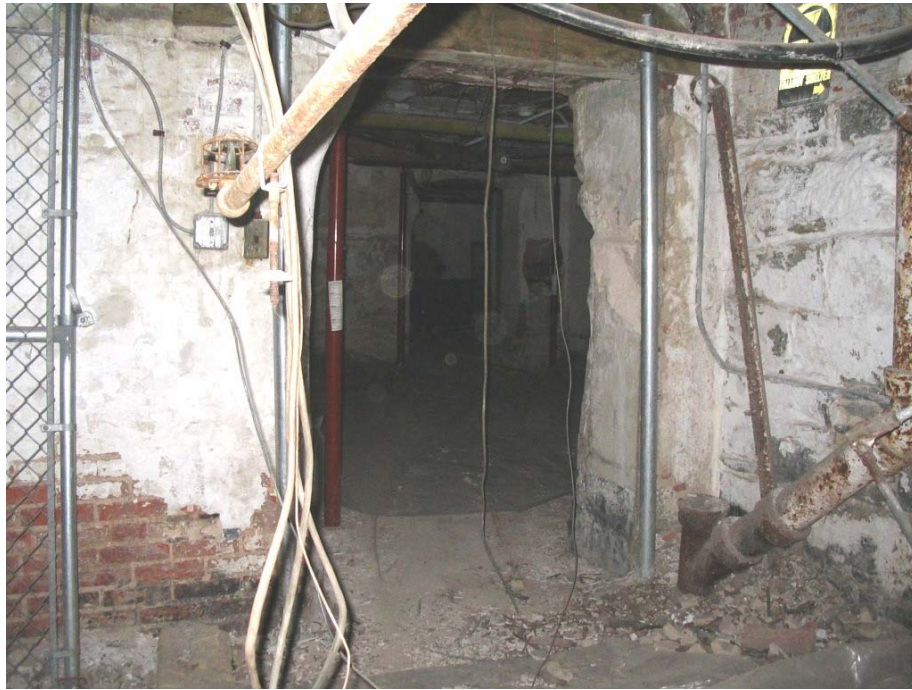
59.1	Several minor vertical cracks on walls. Sections of timber flooring above have been replaced while other sections remain in a deteriorated state.
59.6	Moderate to heavy debris scattered throughout areas.
402.1,2,3,6	Moderate to heavy corrosion on utility pipes and conduits. Some sections of pipes, conduits, and wiring are sagging and hanging from ceiling.

Photo 3: Looking east, east portal in distance; Note hanging electric and phone wires

1. Remove debris from floor, 10 CY.
2. Replace electric lines, 170 LF.
3. Replace lighting conduits and wiring, 170 LF.

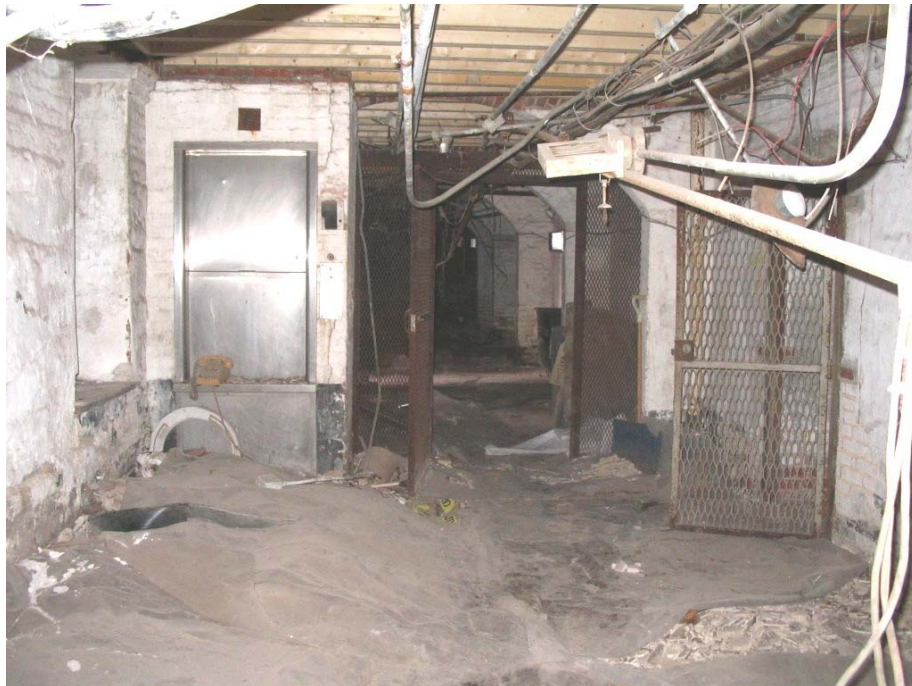
Photo 4: Looking west; Note hanging conduits and wires

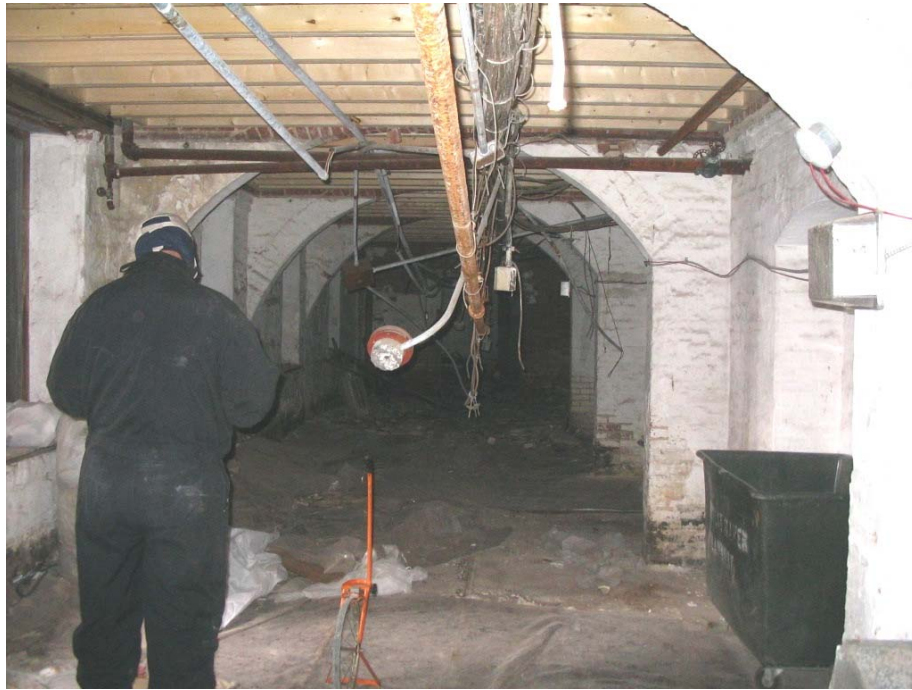
Photo 5: Looking west; Note new timber floor above and hanging utilities

1. Shore or replace deteriorated timber flooring above not yet repaired.

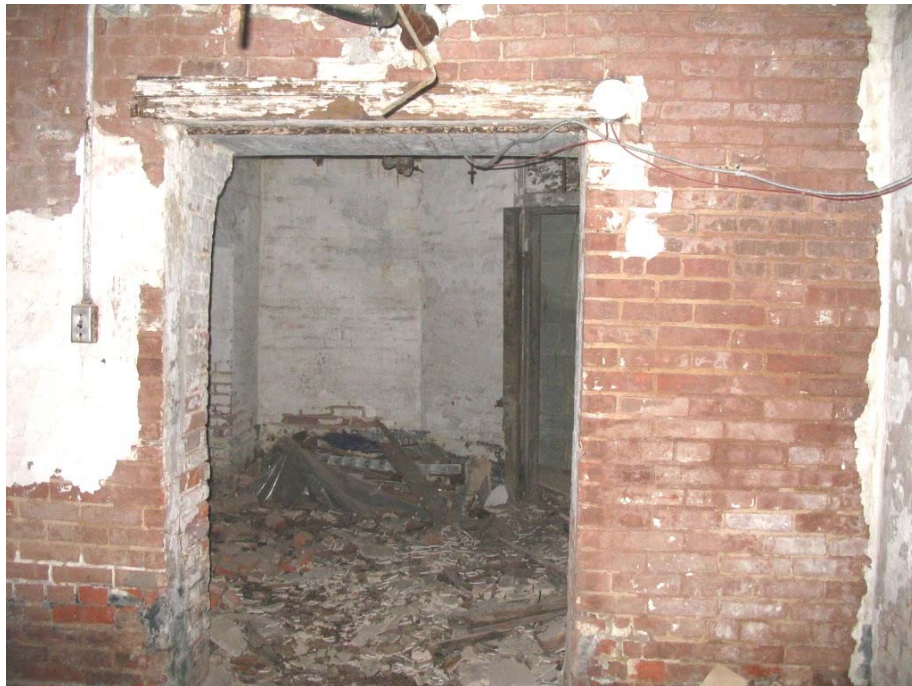
Photo 6: Debris on floor

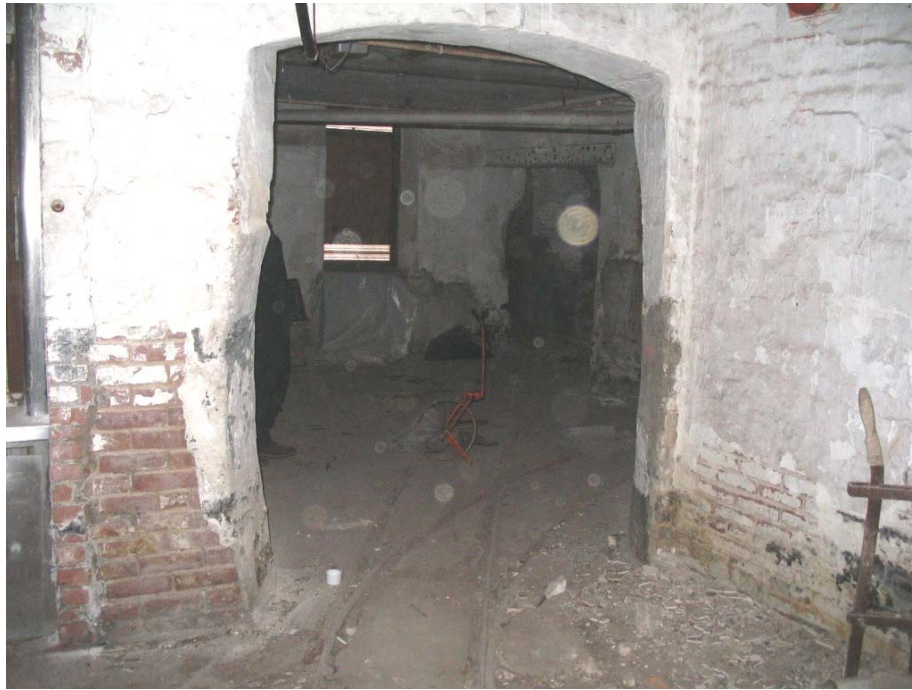
Photo 7: West portal, east face; Note vertical crack on south side

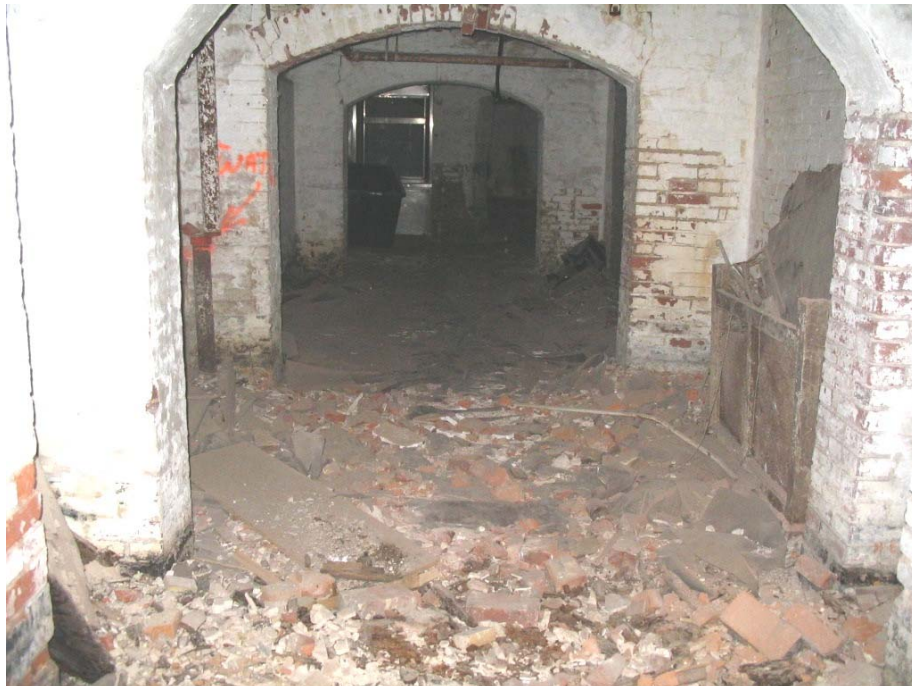
Photo 8: Debris on floor, looking west

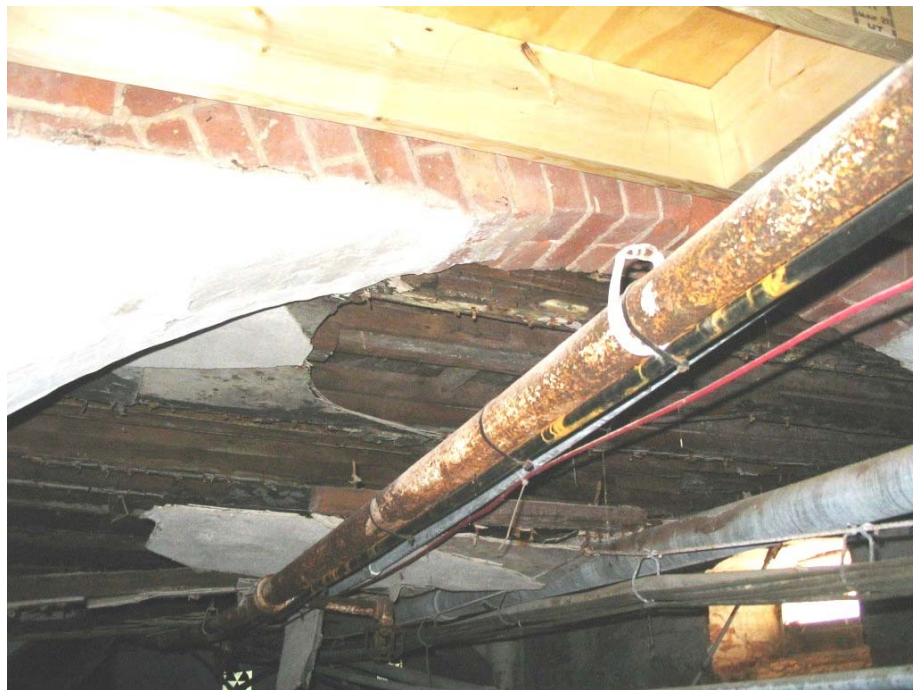
59.1	Sections of timber flooring above have been replaced while other sections remain in a deteriorated state.
59.6	Moderate to heavy debris scattered throughout floor in areas.
402.1,2,3,6	Moderate to heavy corrosion on pipes and conduits. Utilities are sagging and hanging from ceiling at east end of tunnel.

Photo 4: Deteriorated timber floor system above;
Note new flooring in adjacent area

1. Shore or replace areas of deteriorated timber flooring not yet repaired.

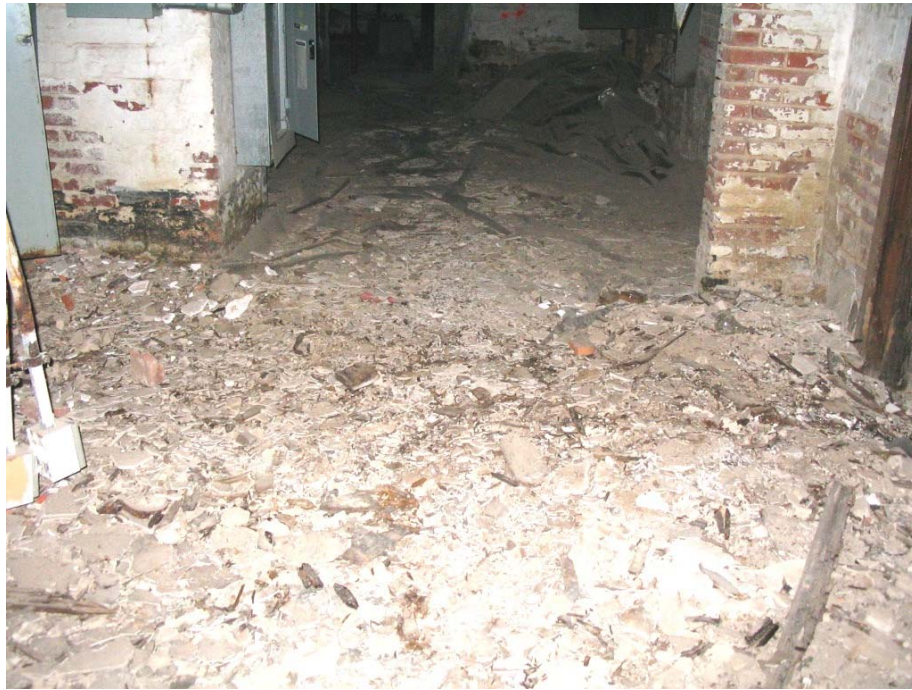
Photo 5: Heavy debris on floor

1. Remove debris from floor, 20 CY.
2. Replace electric lines, 170 LF.
3. Replace lighting conduits and wiring, 170 LF.

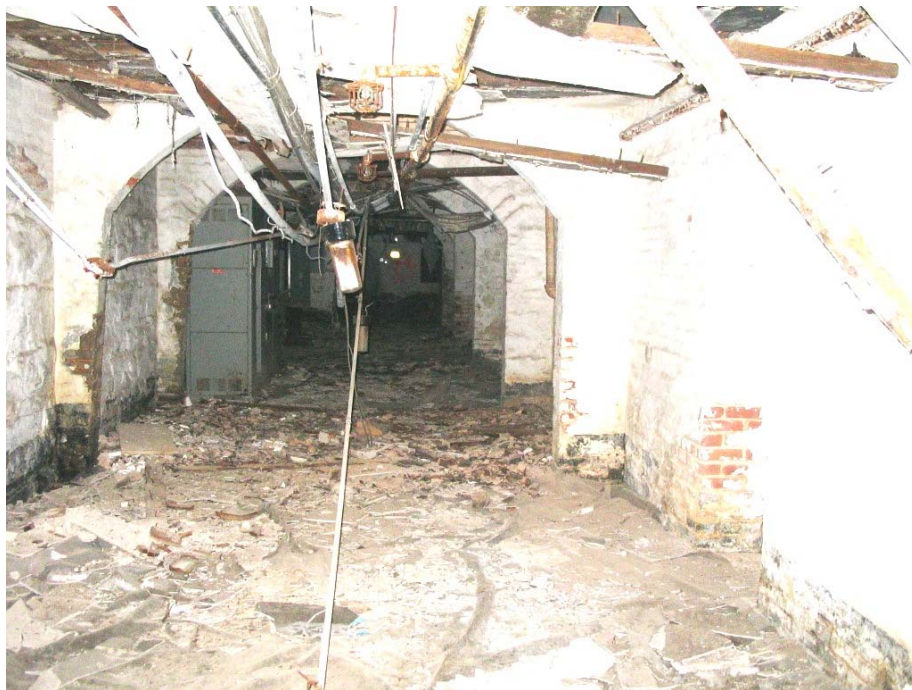
Photo 6: Unsupported and hanging utilities; Note debris on floor

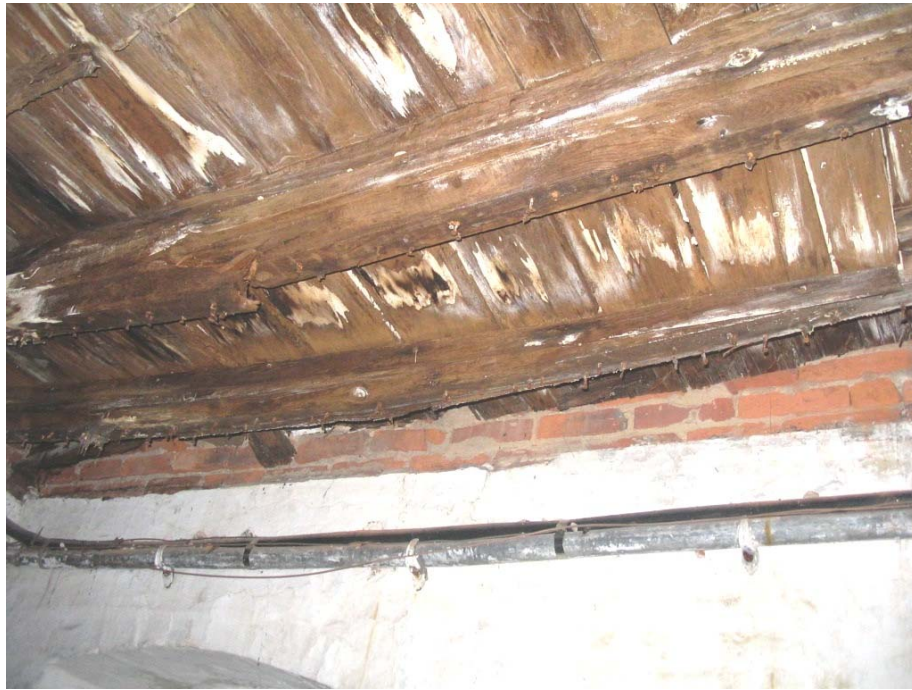
59.1	Sections of timber flooring above have been replaced while other sections remain in a deteriorated state. One section of deteriorated timber flooring above is settling.
59.6	Minor to moderate debris scattered along floor. Heavy debris accumulation near west end of tunnel.
402.1,2,3	Moderate to heavy corrosion on pipes and conduits. Conduit near west end has an area of total section loss.
402.3,6	Conduits and wiring sagging and hanging from ceiling.

Photo 3: Deteriorated and settled timber flooring above

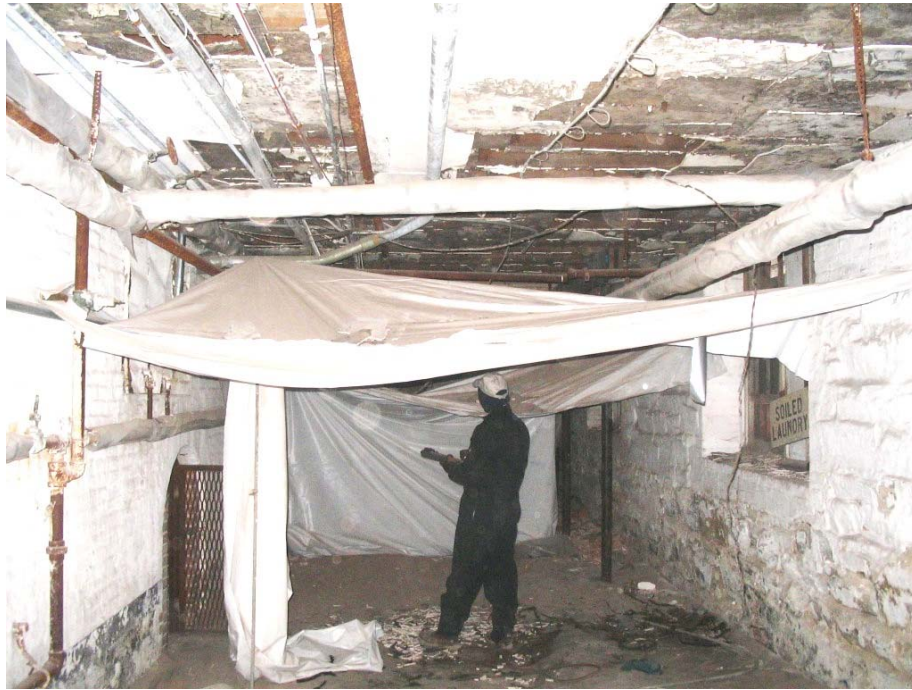
Photo 5: General view of tunnel deteriorated timber flooring above, looking west;
Note and corrosion on conduits and hanging wiring

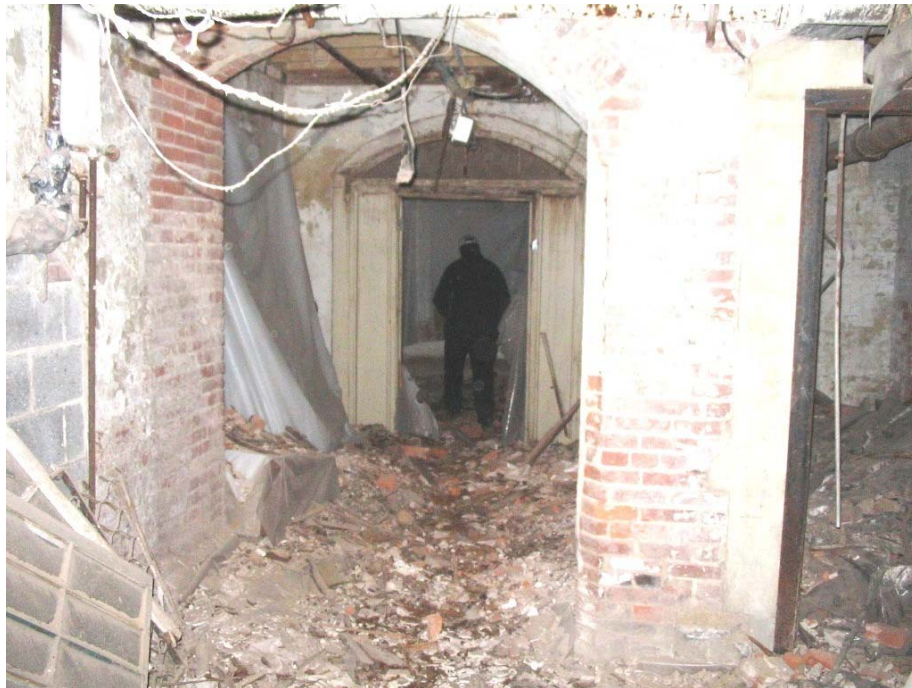
Photo 6: Heavy debris on floor; Note hanging wiring

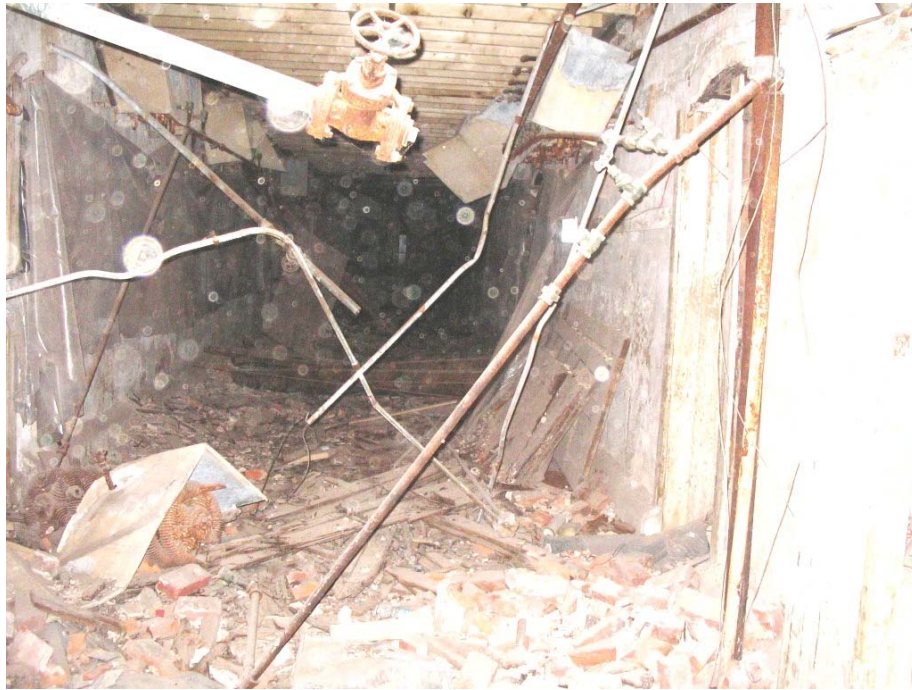
Photo 7: Heavy debris on floor; Note hanging pipe, conduits, and wiring

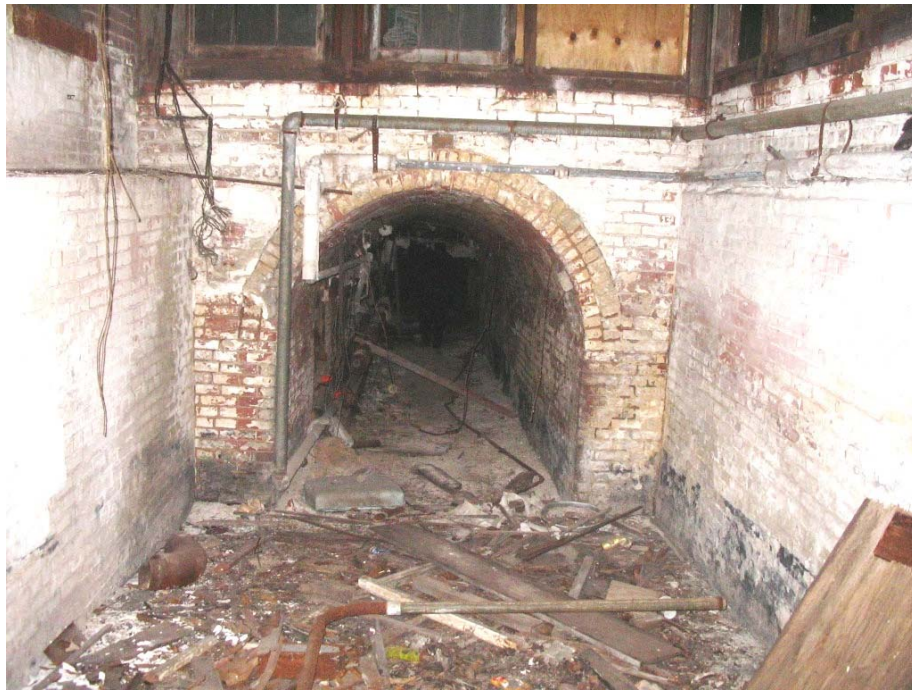
Photo 8: East portal of arch portion at west end of tunnel; Note heavy debris on floor

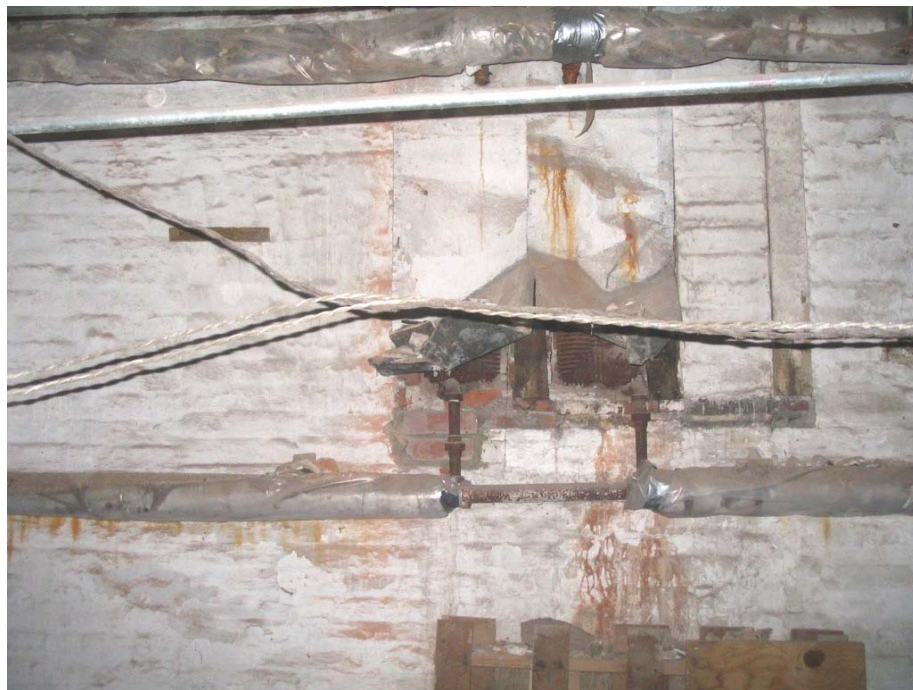
Photo 10: Corrosion on steam pipe, south wall

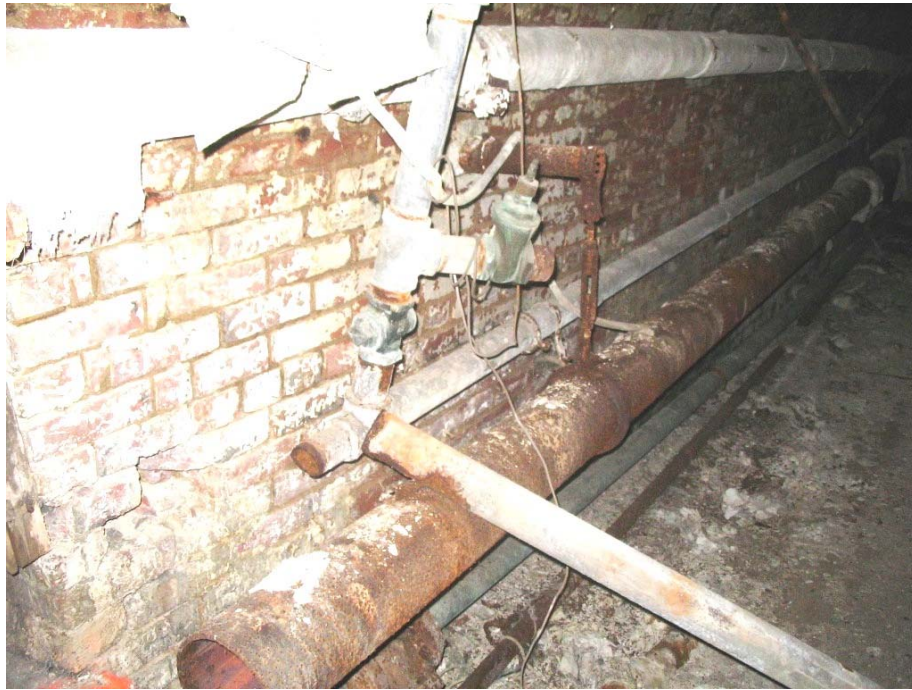
Photo 11: Corrosion on steam pipe in arch section of tunnel near west end

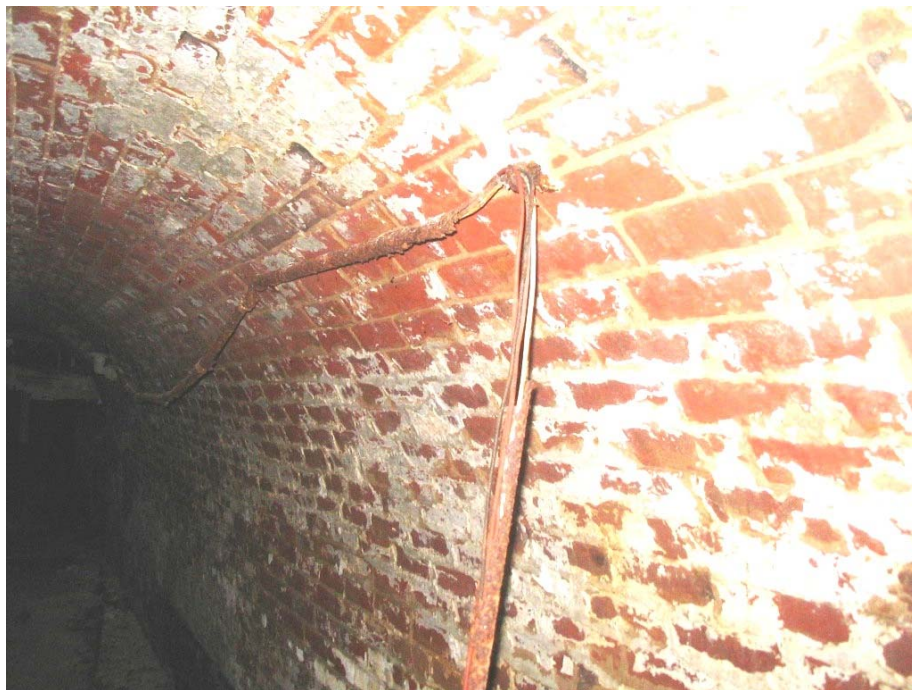
Photo 12: Corrosion with total section loss on conduit

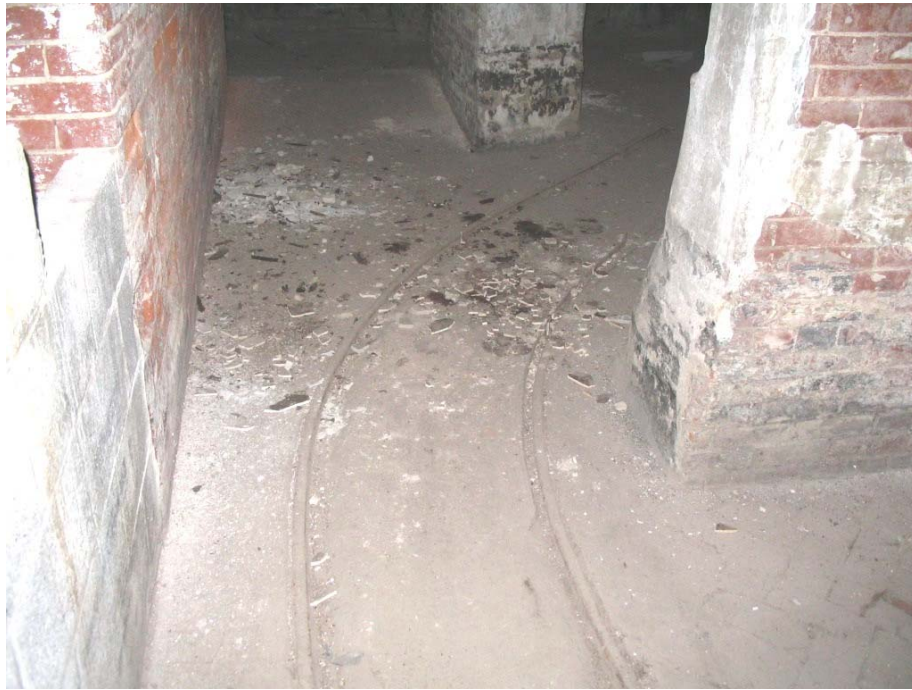
Photo 5: Looking north toward north portal;
Note minor debris on floor

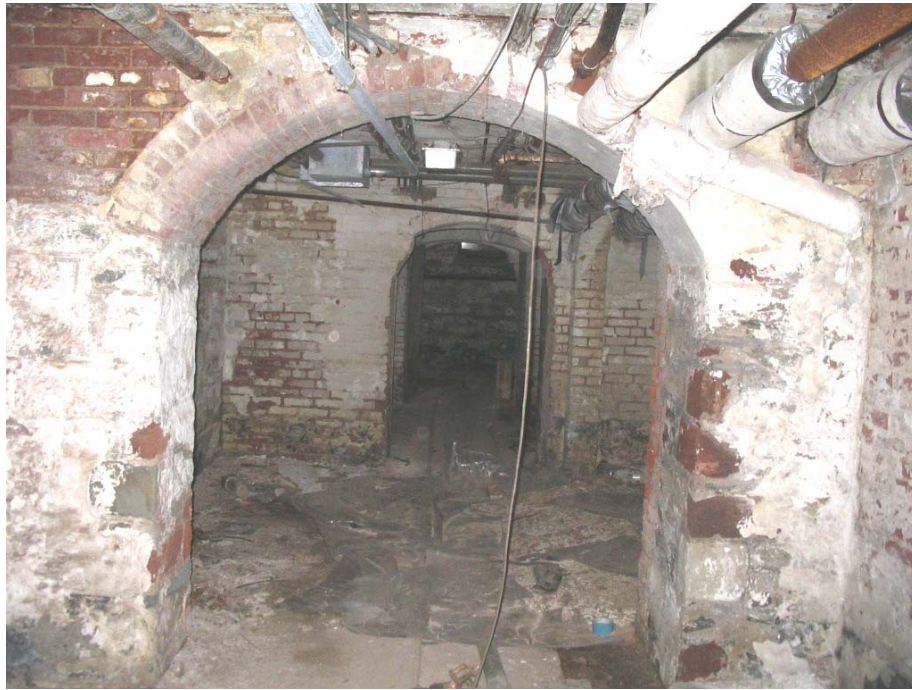
59.6	Minor debris on floor in areas throughout.
402.1,2,3	Moderate to heavy corrosion on pipes and conduits. Some pipes and conduits are unsupported and hanging from ceiling.
402.6	Telephone lines are loose from ceiling and hanging in areas.

Photo 3: General view looking west from east portal; Note hanging wiring

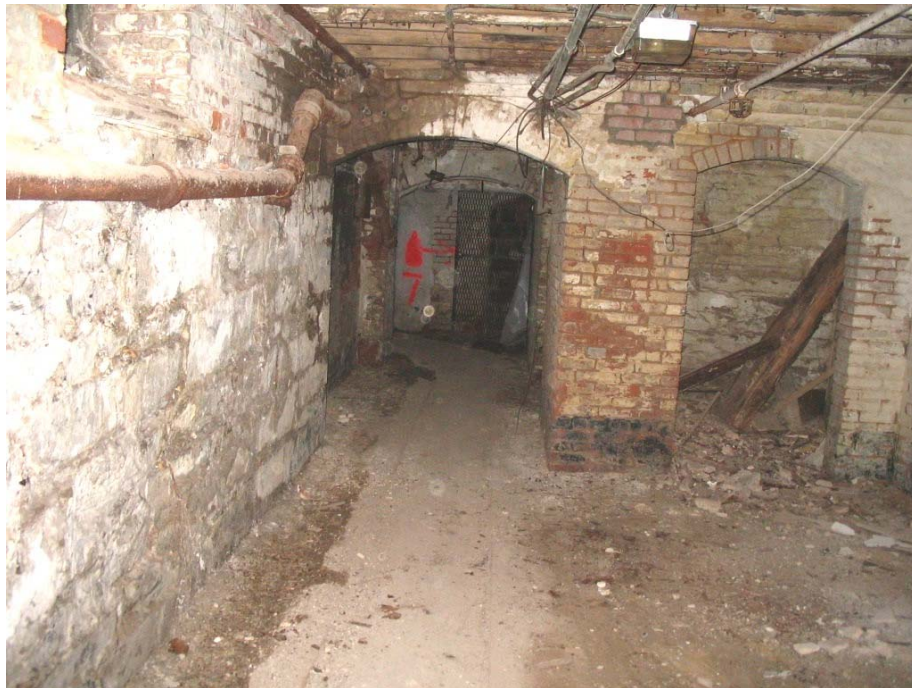
Photo 4: General view looking west; Note debris on floor, hanging wiring, and corrosion on pipes

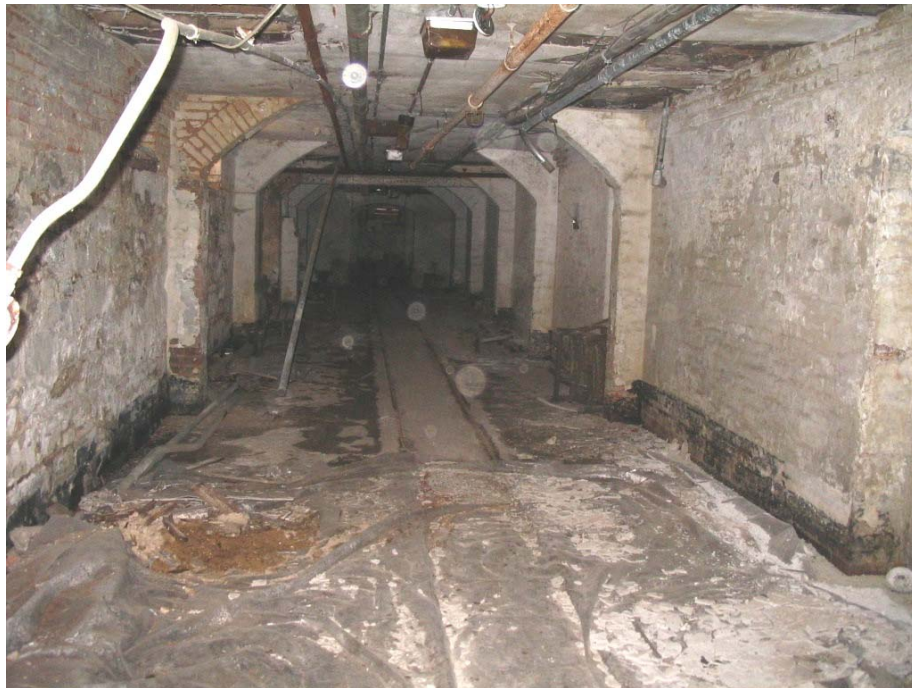
Photo 6: Debris on floor; Note hanging conduits

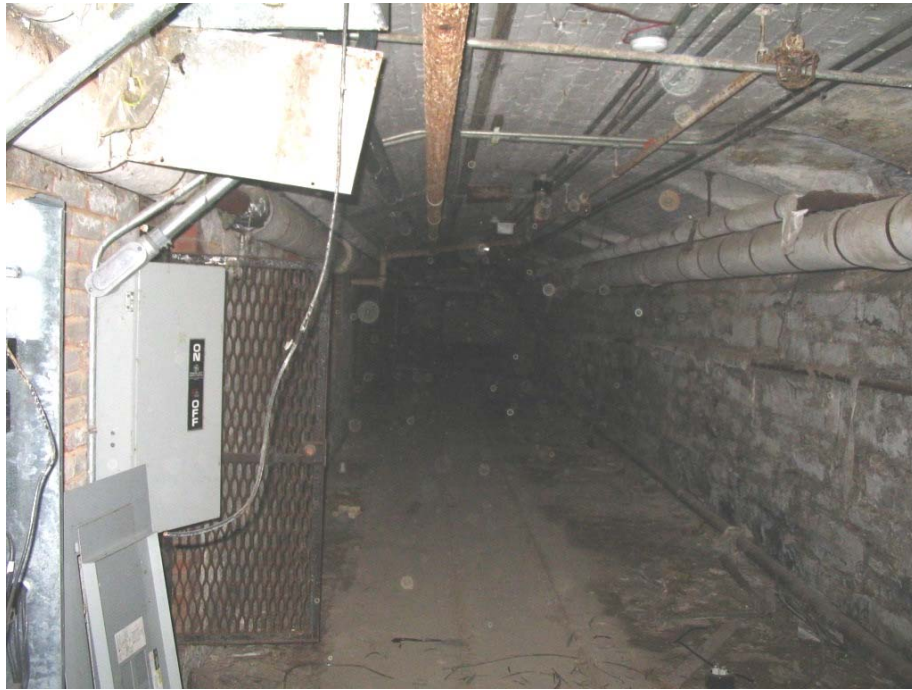
Photo 7: Corrosion on piping and conduits

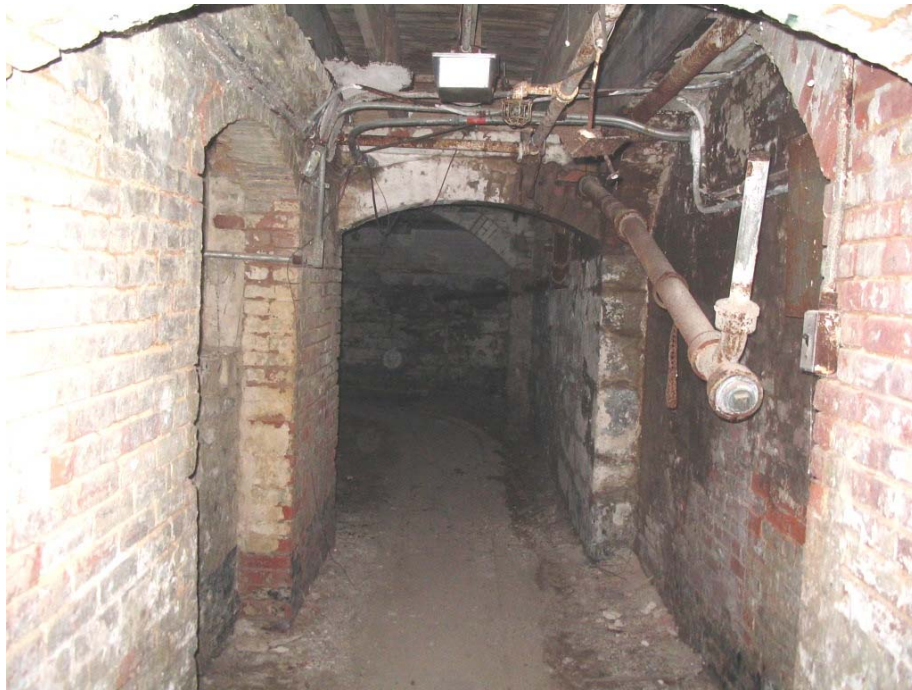
Photo 8: Hanging pipe near west end; Note corrosion on piping and conduits

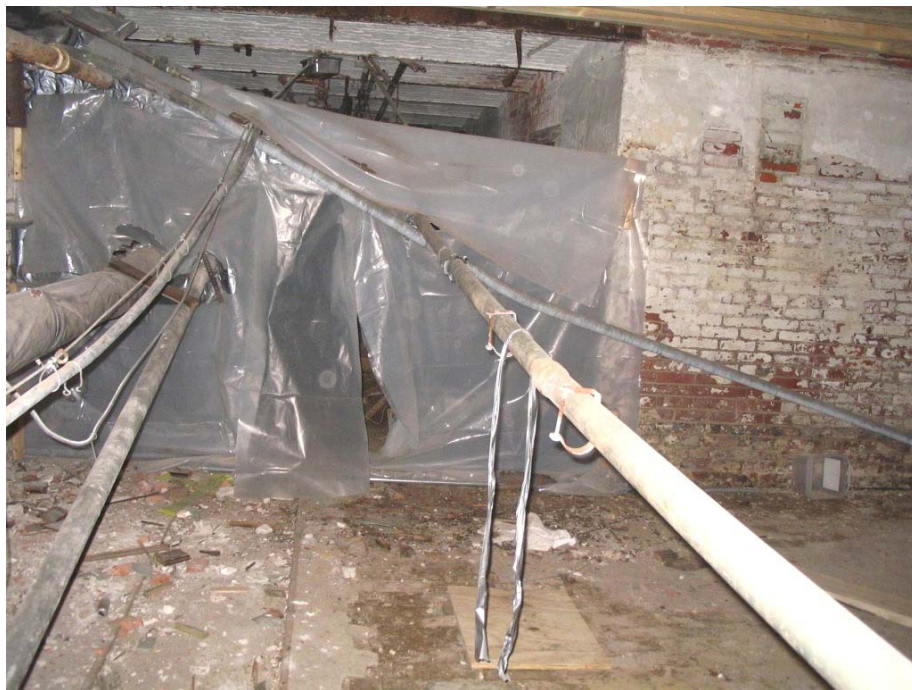
59.6	Minor to moderate debris scattered on floor.
402.1	Steam pipes are wrapped with exposed sections showing signs of moderate corrosion.
402.2,3	Heavy corrosion on water pipes and electrical conduits.
402.6	Phone wires loose from ceiling with loss of coating.
402.1,2,3,6	Utilities are loose and unsupported in areas.

Photo 2: West portal; Note hanging and unsupported utilities

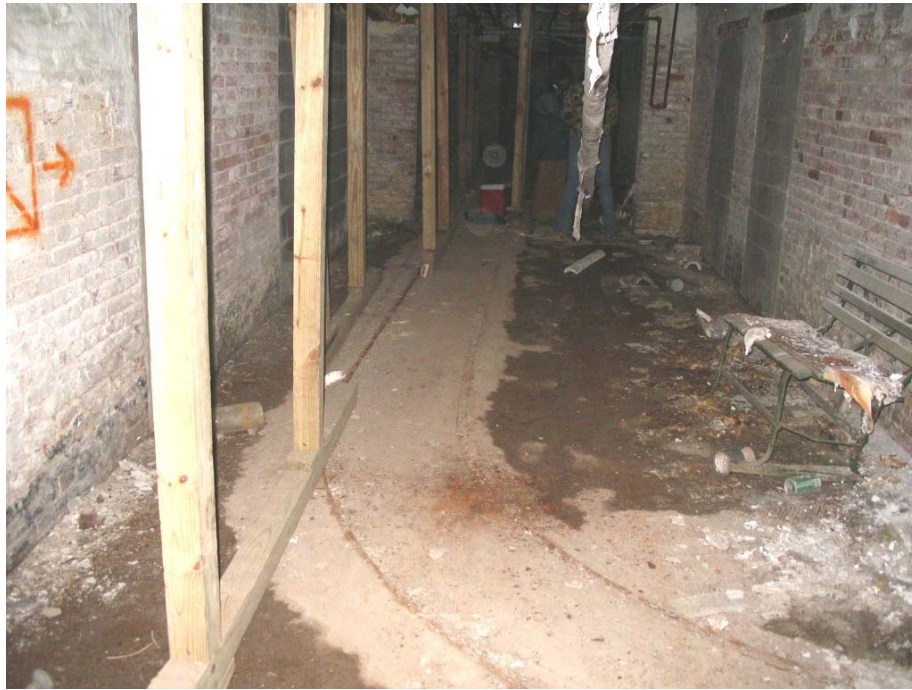
Photo 3: Looking west from east portal;
Note minor debris and dampness on floor

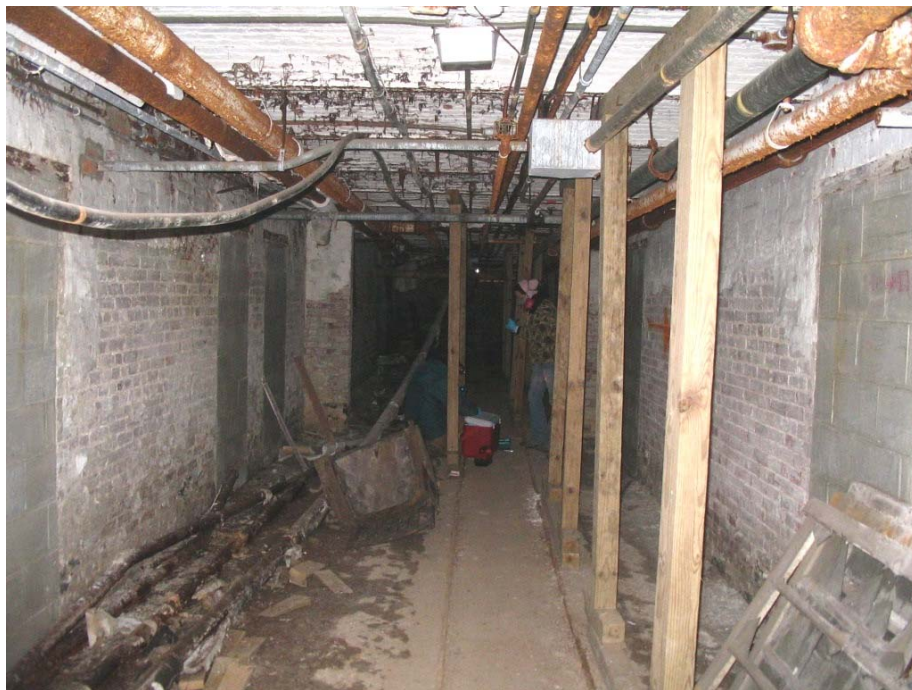
Photo 4: Looking east; Note debris and sagging cable

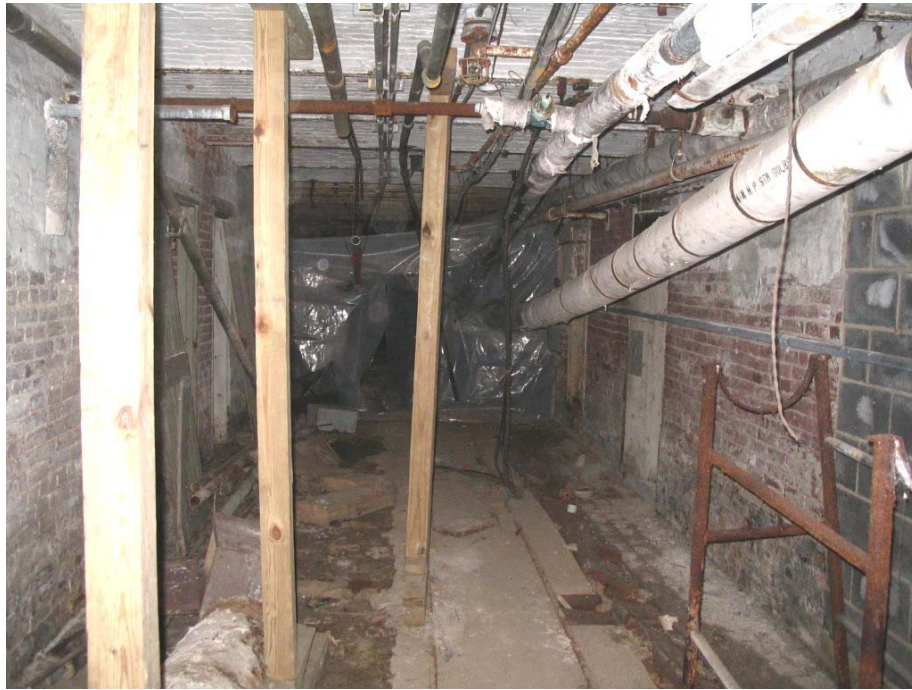
Photo 5: Looking west toward west portal; Note debris and unsupported utilities

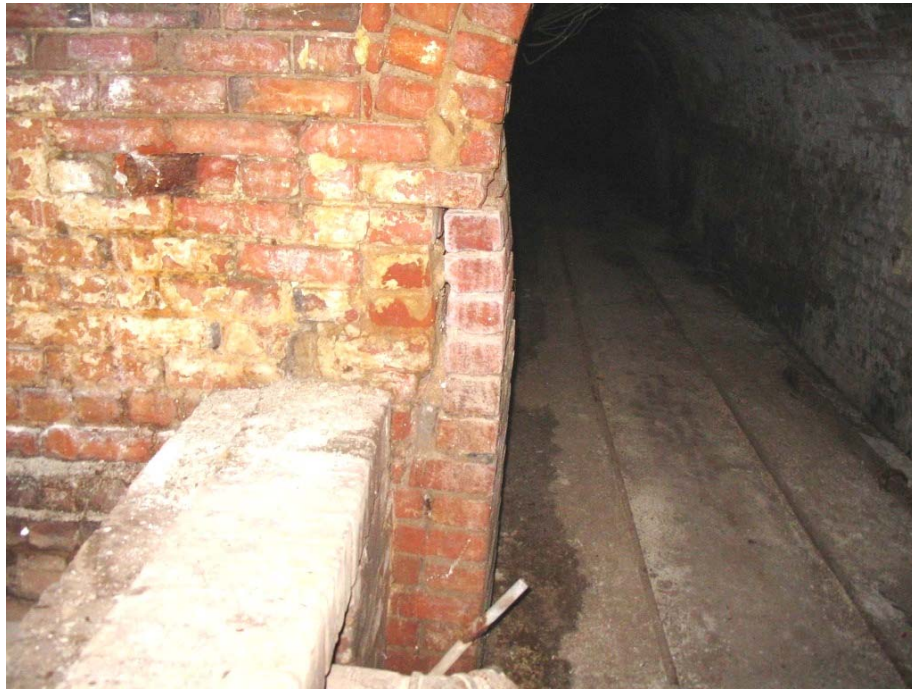
59.2	Separated bricks along arch ring on west side of south portal.
59.6, 402.2	Minor to heavy debris on floor. Water utility on floor.
402.2,3,6	Moderate to heavy corrosion on pipes and conduits. Sections of electrical and phone wiring hanging from ceiling.

Photo 5: Deteriorated mortar joints on west wall of south portal, looking north

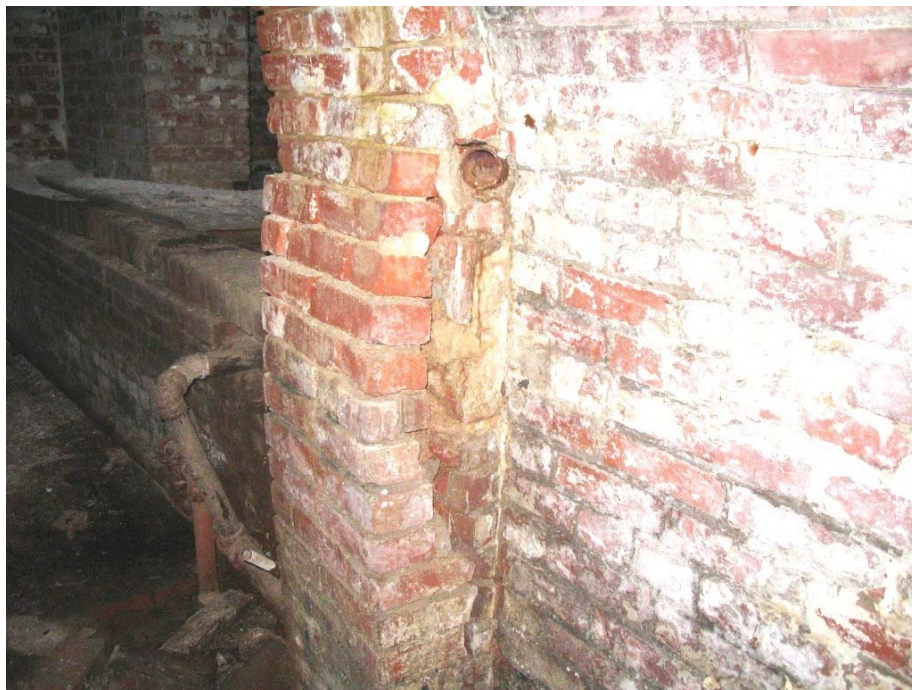
Photo 6: Deteriorated mortar joints on west wall of south portal, looking south

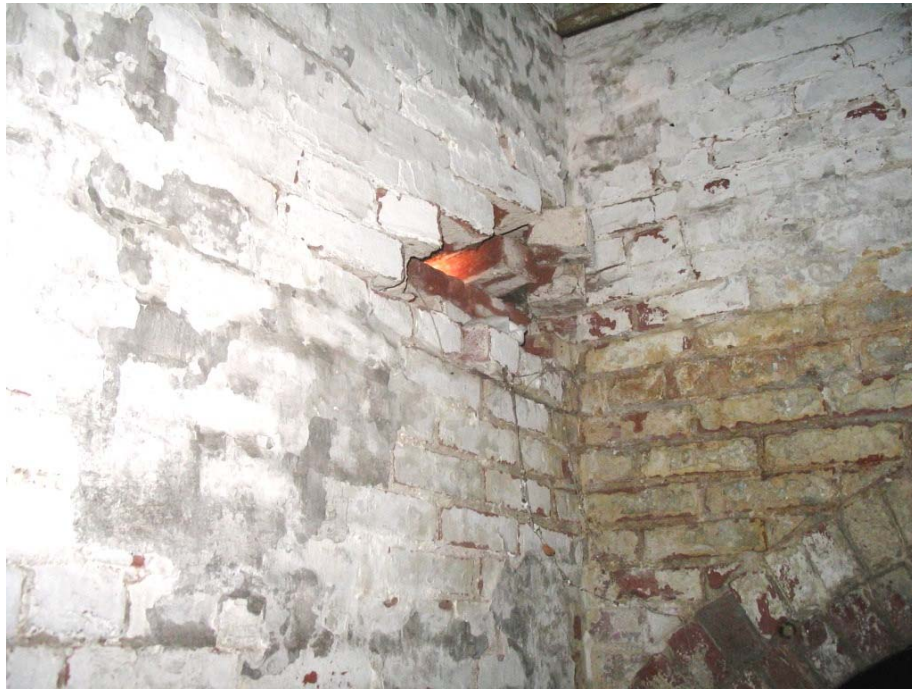
Photo 7: Missing bricks at vault connecting to Building 6

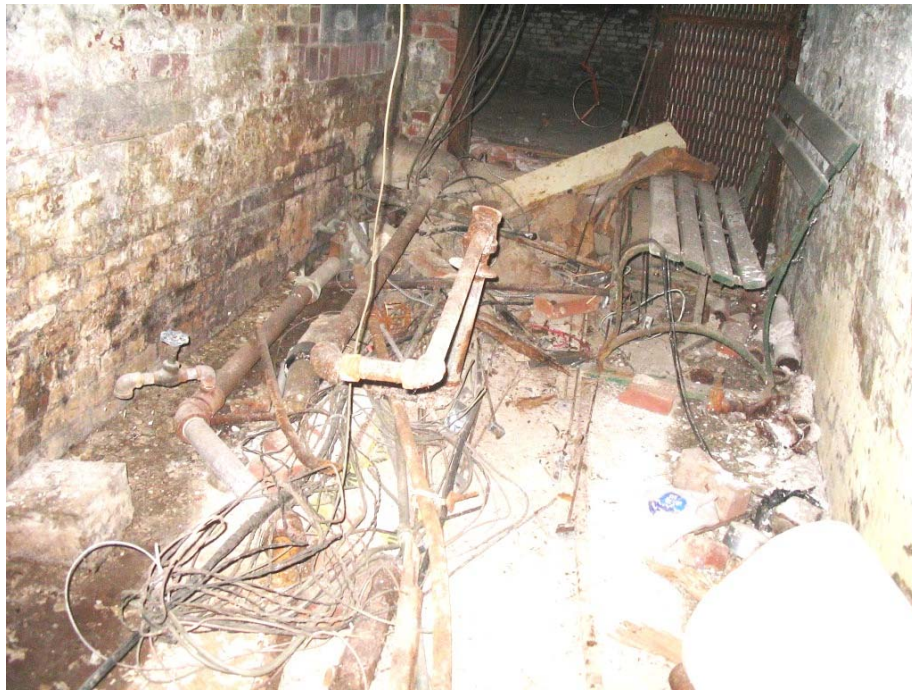
Photo 8: Debris on floor near entrance to Building 6

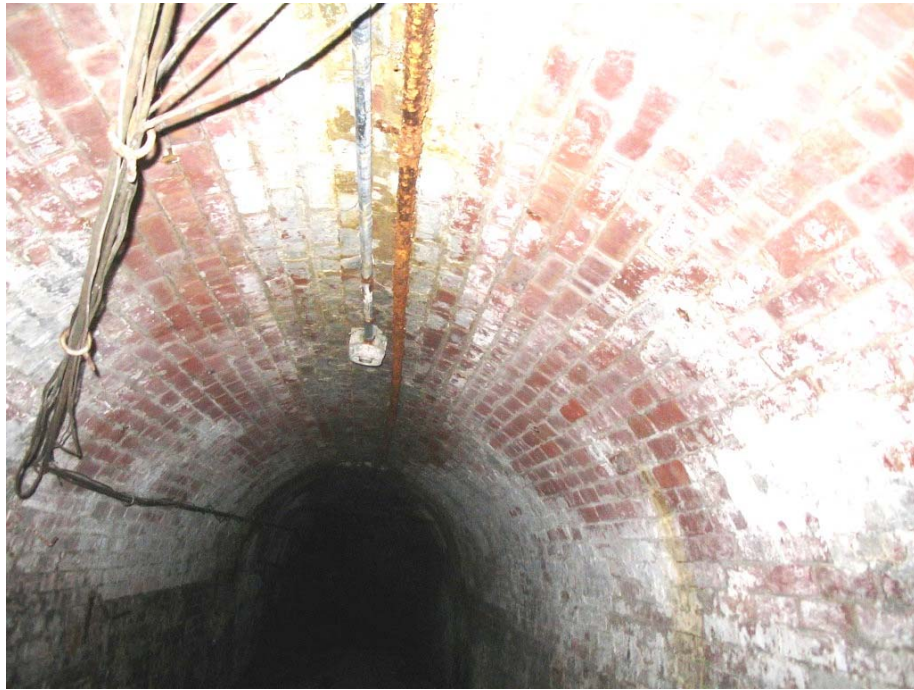
Photo 9: Corrosion on conduits; Note damaged light fixture

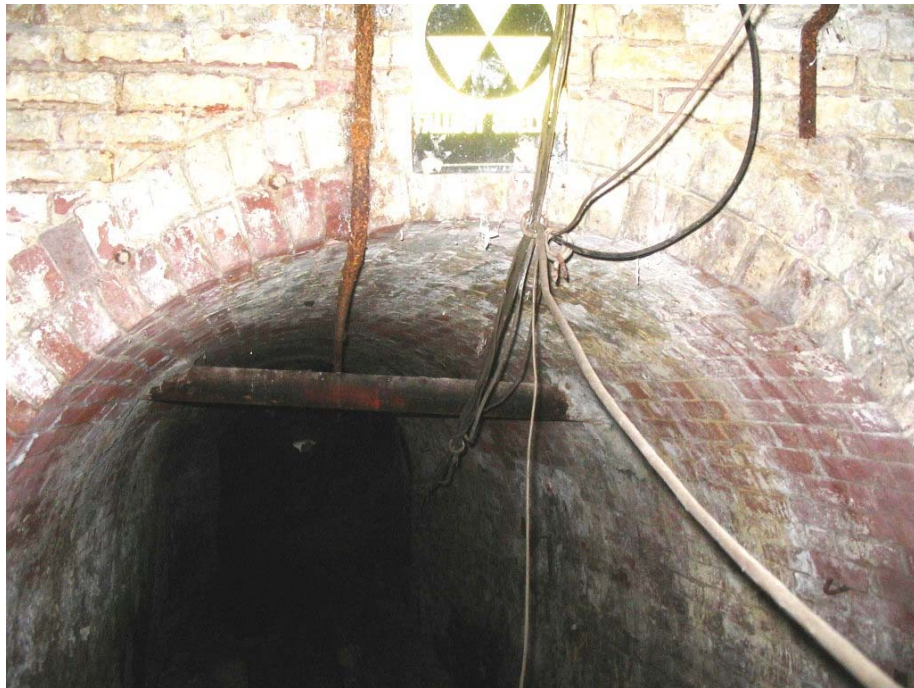
Photo 10: Hanging telephone and electric wires at north end of arch;
Note corrosion on conduit
